SAFETY ALERT

Safety Alert No. 346
25 January 2019

Fractures Found on Stainless Steel Fittings

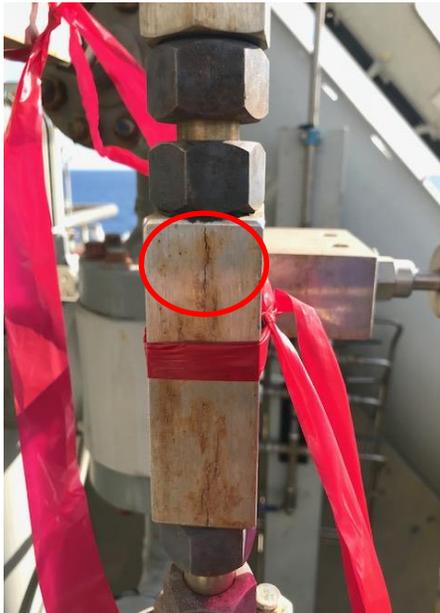
In November 2018, BSEE was notified of multiple fitting failures occurring on a Gulf of Mexico facility's chemical injection skid that was recently placed in-service. The deficiencies observed consisted of cracks along various fitting bodies. These cracks can potentially lead to threatening high-pressure gas releases. Furthermore, unused Parker Hannifin IPD (Parker) 316 Stainless Steel (SS) MPI™ fittings arrived at an offshore facility and were determined to be unsuitable for installation. Parker is currently reviewing the root cause(s) for these failures and establishing effective corrective actions. Although the primary type of fitting associated with these fractures has been identified as the Parker 316SS MPI™, this has been an issue discovered on other manufacturer fittings throughout the Gulf of Mexico.

Cracked Fitting Previously In-Service

- Identify the Parker 316SS MPI™ fittings (as well as fittings of similar design) on your facilities and inspect for damage. If cracks or other deficiencies are detected, contact the manufacturer directly per Parker's product quality alert.
- Schedule more frequent inspections of the equipment that utilize this type of fitting. Apply the fittings to your Quality Assurance / Mechanical Integrity system as a focal point for inspections.
- Include the fittings for review within future facility hazard analyses (if applicable).

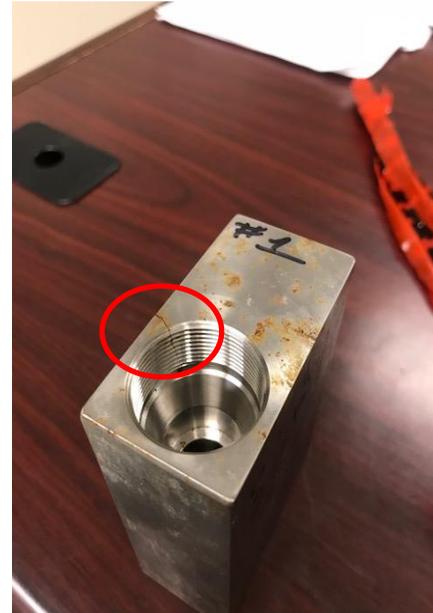
Cracked Fitting Sampled from Stock
